Assessment of Potential Archaeological Collections Facility Sites at Eaker Air Force Base, Blytheville, Arkansas

Archaeological Curation-Needs Assessment
Architectural-Archaeological Report No. 2

U.S. Army Corps of Engineers

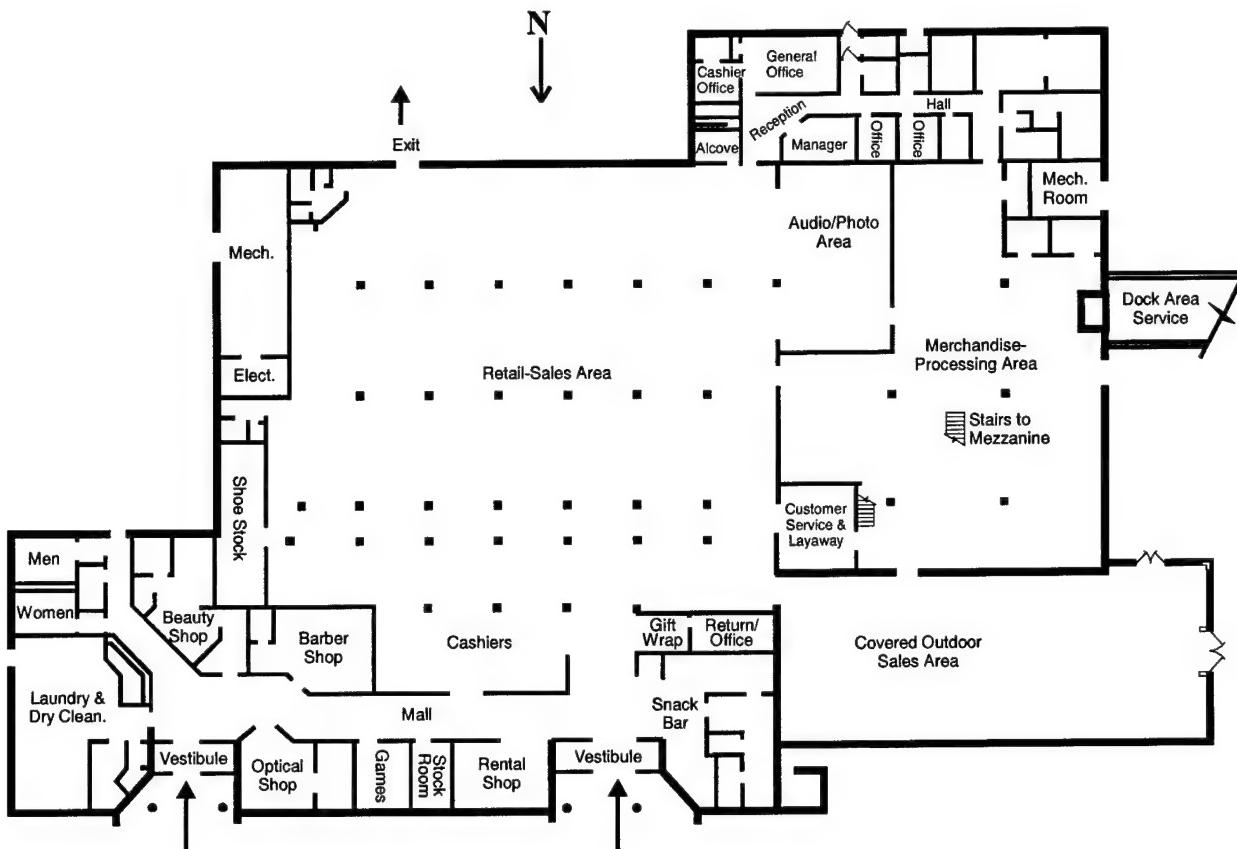
Figure 5. Floor plan of Building No. 552 (not to scale).

Base Exchange Building No. 552 (Figure 4) was constructed in 1956 and renovated in 1987; it encompasses 32,925 ft² (Figure 5). The initial space needed for the proposed MVCHC is 22,866 ft², with a potential for future expansion up to 39,880 ft². The expansion needs are for additional artifact-storage space; this will

presumably become necessary within approximately 10 years. The initial need for 22,866 ft² can be met immediately, with 10,069 ft² unoccupied until a later time when the space will be needed. When the total of 39,880 ft² is needed, the storage area can be remodeled into a two-level plan. This will double the amount of storage space.

Many of the spaces within the existing building were constructed for uses similar to that needed for the proposed MVCHC. For example, the building has a loading dock, dock leveler, and receiving area, which could be used with no alteration for the MVCHC. In general, only minor structural modifications would be necessary to adapt the building to the proposed use. The majority of space in the existing building is single story; however, a portion of the building is a two-story space currently occupied with a steel mezzanine and two levels of storage (Figure 6). Medium-duty steel shelving remains from the building's previous use as the base exchange. Existing shelving would suffice for lightweight objects, but heavy-duty shelving units would be necessary to support the weight of lithic collections. The current square footage could be doubled by utilizing the mezzanine concept for storage when additional storage space is needed.

Adjacent to the main entrance are a series of rooms that formerly housed retail shops. These rooms can be converted to offices with little modification. Beyond the former retail areas, still close to the main entrance, is a large open space that can be modified to serve as exhibit space by making substantial changes to the

Base Exchange Building No. 552 is recommended as one of two potential buildings at Eaker AFB that could be rehabilitated for use by the AAS as the MVCHC.

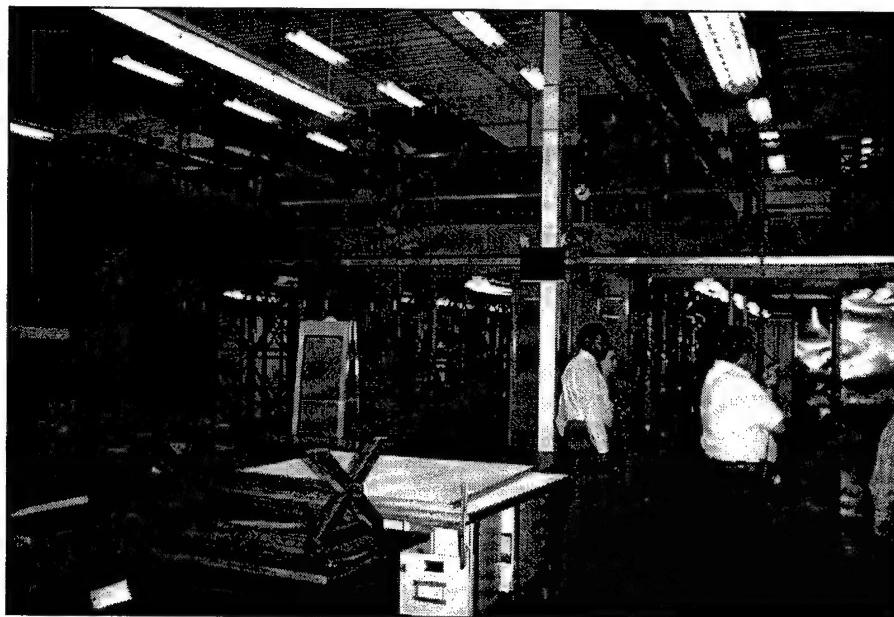
Figure 6. Interior view of Building No. 552 showing existing steel shelving.

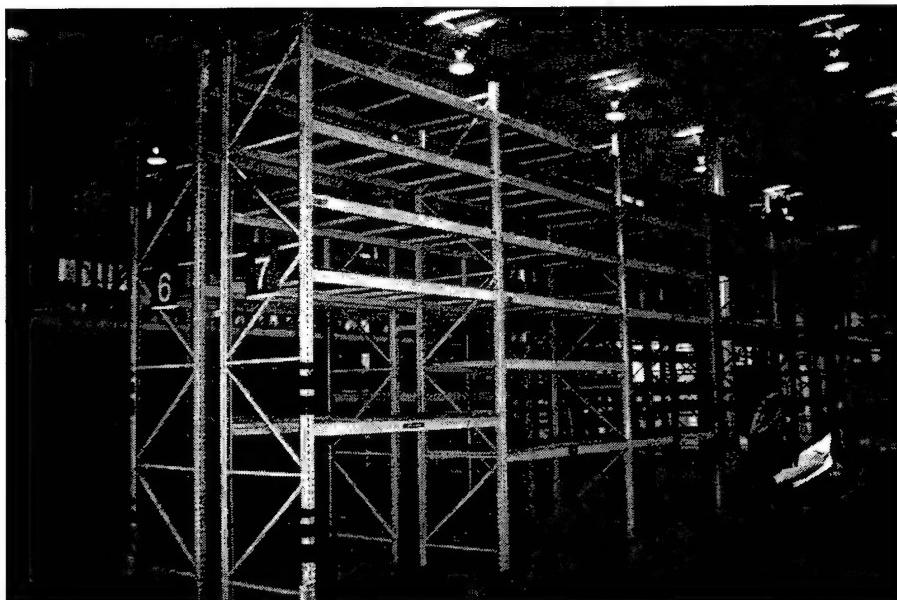
The existing warehouse space is three-stories high (32 feet high), encompasses approximately 10,000 ft², and contains many heavy-duty storage racks. The storage racks (Figure 9) are approximately 20 feet high and must be accessed by mechanical lifting devices. This storage environment was used for bulk items such as furniture or large boxes; it is doubtful that this large space could be put to a productive use without significant alterations and additions of intermediate floor levels. This building is not considered to be a reasonable choice for use by the AAS as the MVCHC.

Figure 9. Interior view of Building No. 556 showing warehouse space.

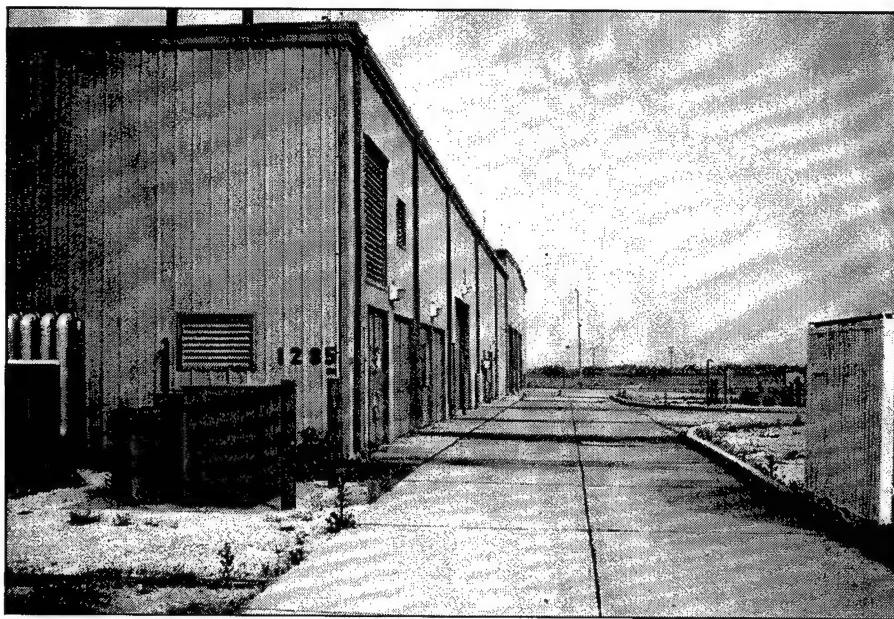
This is a reinforced-concrete building with exterior, metal siding (Figure 10). The building was constructed in 1985; it encompasses 32,336 ft², of which approximately 28,104 ft² is ideal for industrial or manufacturing uses (Figure 11). The

Figure 10. Missile Assembly Building No. 1285.

The Blytheville-Gosnell Regional Airport Authority is of the opinion that the best use of this building will include some type of manufacturing function. After inspecting the building, we agree with this conclusion and find that the building would be underutilized as a cultural heritage center. This building is not recommended for use by the AAS as the MVCHC.

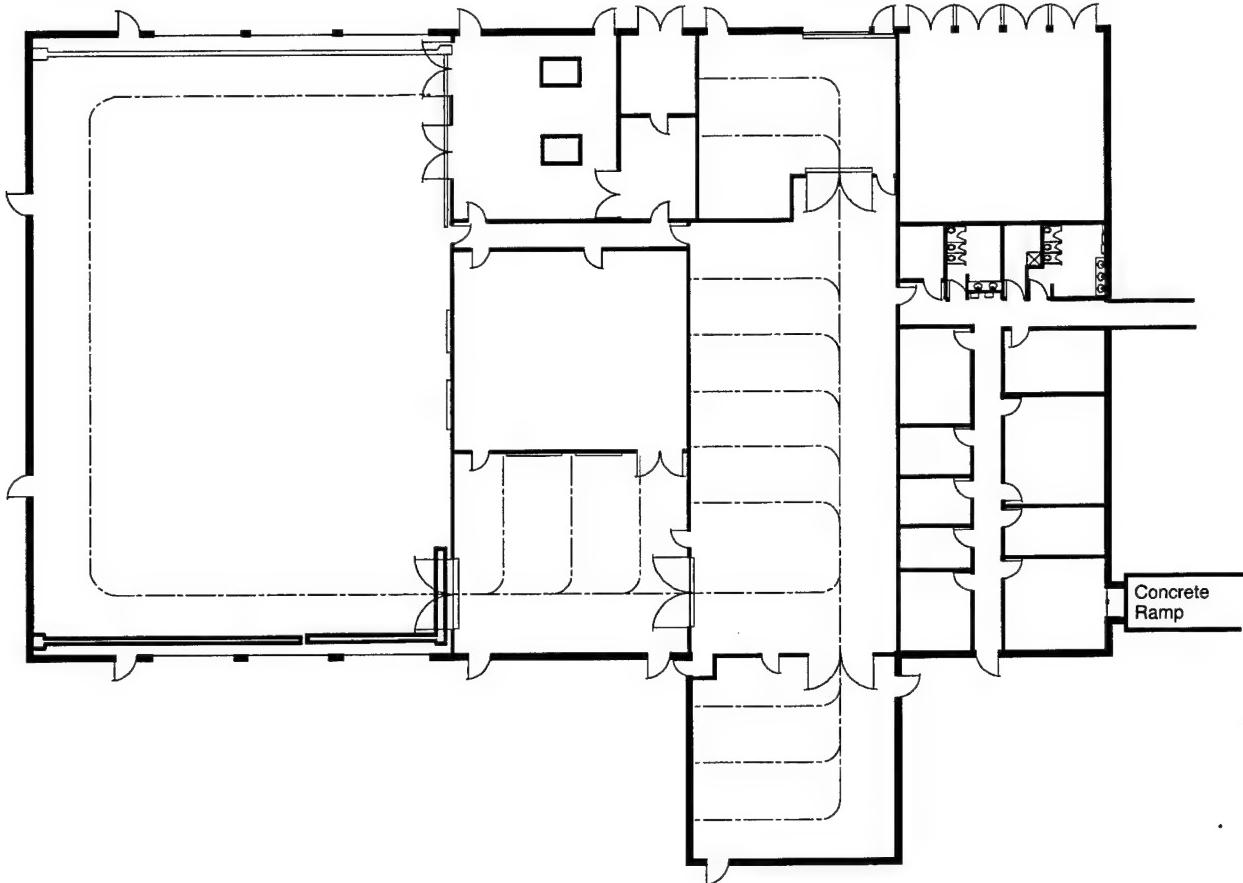
Figure 11. Floor plan of Building No. 1285 (not to scale).

remaining 4,232 ft² is best utilized as office space. A very substantial building in good condition, it has a continuous overhead crane rail that connects all of the industrial rooms (Figure 12). The industrial areas are accessed through 12-x-20-foot swinging doors.

The industrial nature of this building makes it ideal for heavy manufacturing or assembly. One can visualize large industrial parts being attached to the overhead crane and carried to and through various rooms for assembly, painting, or finishing.

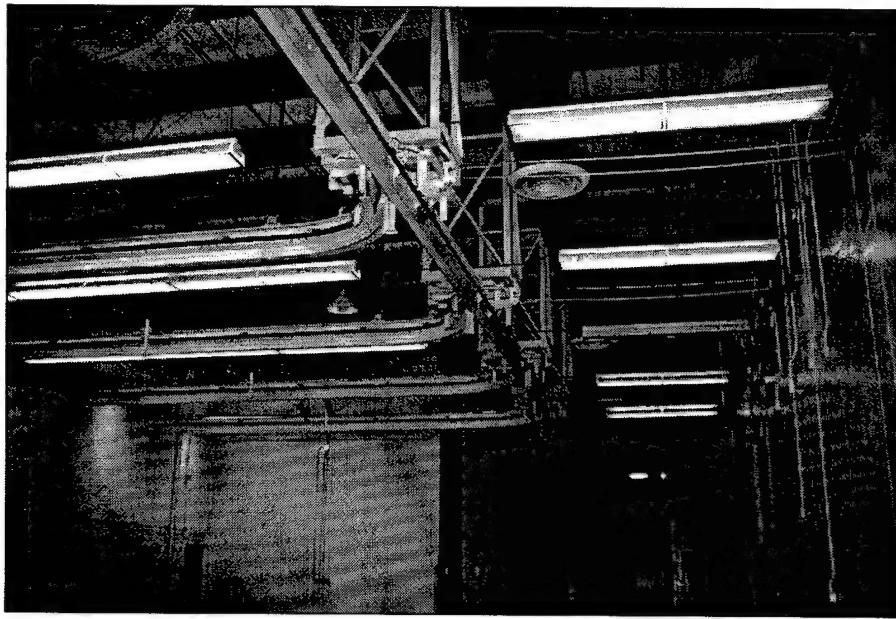
Figure 12. Interior view of Building No. 1285 showing overhead crane and doors that separate the rooms.

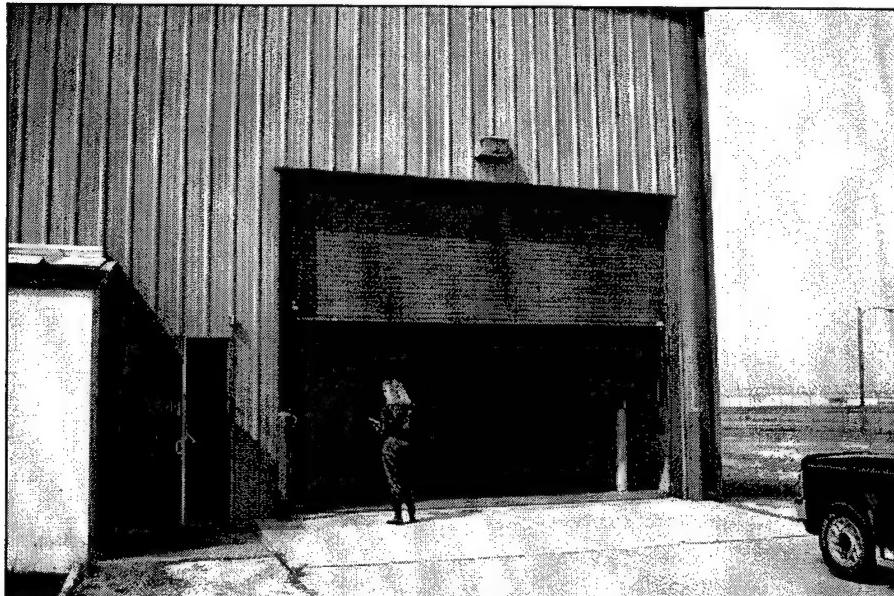
Constructed in 1985, this preengineered, metal building is in very good condition and encompasses 8,951 ft². The building has a heavily reinforced concrete floor that can support substantial loads. Overhead, rolling doors allow vehicle access into and through the building (Figure 13). The interior height from the floor to the bottom of the roof structural members is 31 feet; the building could be divided vertically with an additional floor. Because the building was originally used for storage, it has an unfinished interior. As a result, the entire structural system is exposed to view and uncluttered. These characteristics make the building ideal for future development, because there is very little to modify in the building, and construction could easily begin without

Figure 13. Missile Storage Building No. 1286.

first removing existing finishes or unusable systems. Unfortunately, the program requirements for the MVCHC call for an initial area of 22,900 ft². Building No. 1286 is thus too small, even if a second floor was added. This building is not recommended for further consideration by the AAS as the MVCHC.

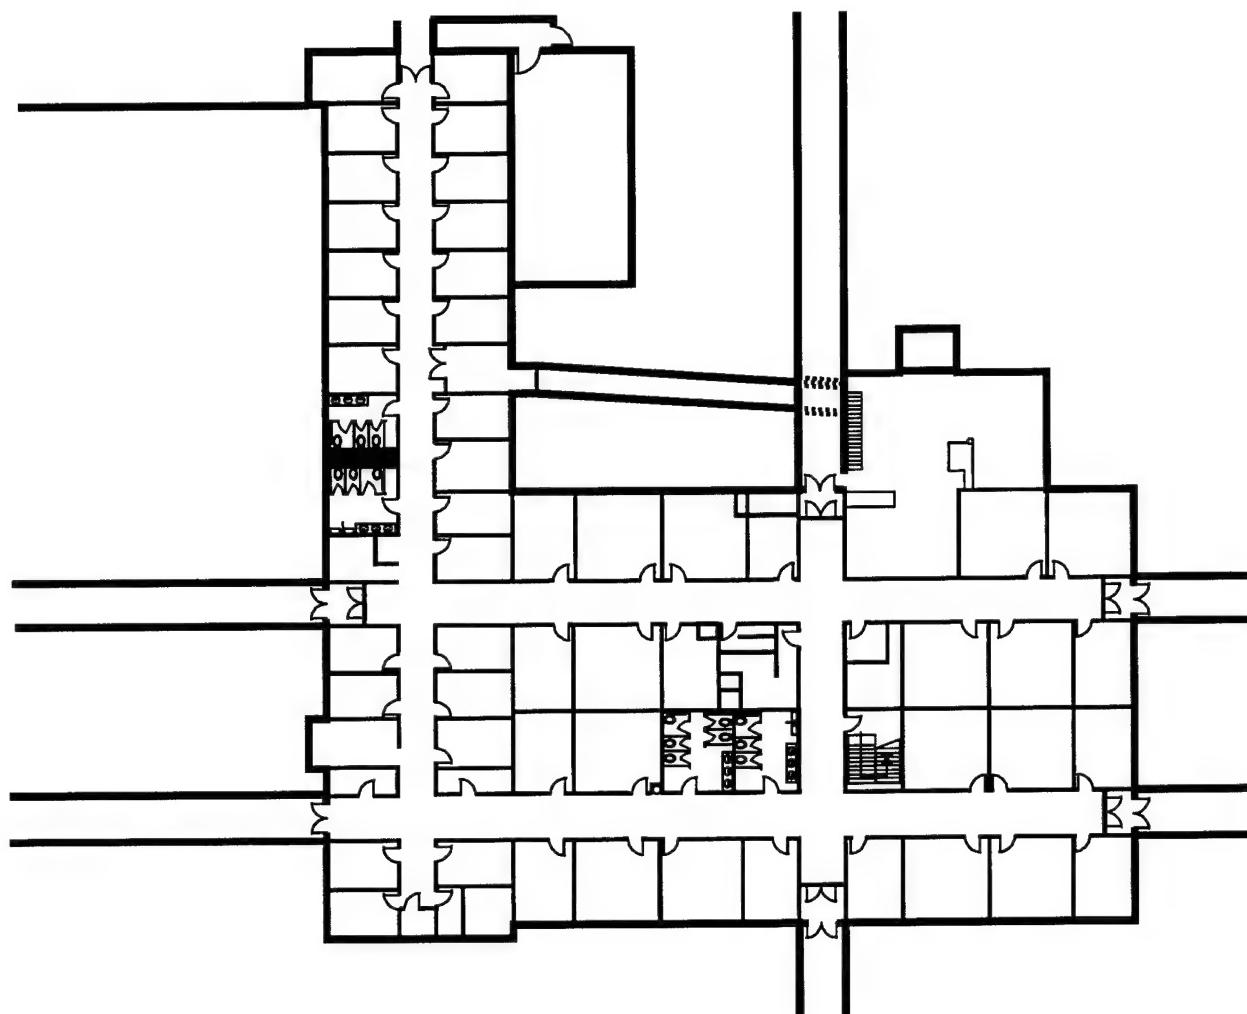
Figure 14. Floor plan of Building No. 1225, lower level (not to scale).

This building was constructed in 1960, and an addition was built in either 1985 or 1986. This is a two-story building that encompasses 28,891 ft². The building is different from the other buildings discussed in this report because the first floor (which is at natural ground level) is earth-sheltered. An earthen berm extends from the natural ground level to just below the second-floor level. The lower level was formerly used as sleeping quarters for pilots and is partitioned into individual sleeping rooms (Figure 14). The upper level contains cooking and dining areas, recreational spaces, a meeting room with an audiovisual projection area, and offices (Figure 15).

Additionally, the lower level is partitioned off into many separate rooms. This would allow ample space for collections storage, and individual collections could be stored intact. This would likely be viewed as an attractive feature to curators.

The disadvantage of using this building as the MVCHC is that none of the existing entrances is well suited for a public facility. To enter the building at ground level and at the lower level, one must walk through a tunnel walkway. To access the upper level from ground level, one must walk up a long ramp. Neither of these means of access is desirable for public use.

To remedy this, it is proposed to create a public entrance at the lower level with means to transport people to the upper level immediately after they enter the building. This would be accomplished by removing a portion of the earthen berm and replacing it with an entrance plaza, constructing an appropriate lobby, and

installing an elevator. These solutions would resolve the need for an appropriate public and handicapped-accessible entrance while taking advantage of the existing earthen berm for storage at the lower level.

The Alert Building No. 1225 is the second of two buildings (the other being the Base Exchange Building No. 552) at Eaker AFB recommended for rehabilitation for use by the AAS as the MVCHC.
